OUR NEW APPROACH TO SUPPLYING EVIDENCE TO WORKSAFE TO OVERCOME WORKSAFE'S RUDE AND OFFICIOUS PEOPLE

Complaint DGC file reference #37798

This location was certified in 2021 for 666kg of in-situ fill LPG and 450 litres of class 3 substances in a NZS4114 work room. There are significant problems with the prior year's certification, including those which pose serious safety issues.

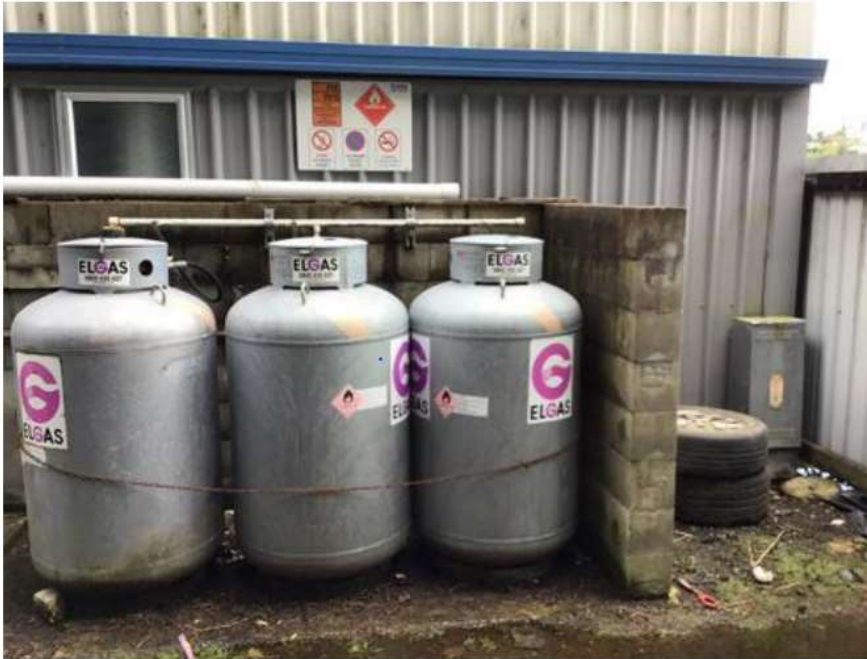
Photo 55

Issue #1 – There are high voltage wires inside the hazardous area – 3.5 metres at the base because the cylinders are *in-situ* filled. Sources of ignition inside hazardous areas are prohibited

There are high voltage electrical cables/mains fuses inside the hazardous area. The site plan used last year for the certification shows that the hazardous area extended to encompass this source of ignition. The mains fuse enclosure was at ground level. The distance from the centre of the cylinders to the fuse box measured 2.4m around a wing wall, however the wing wall was not of sufficient height to mitigate the direct line measurement. In a direct line the fuse box was 1.45m. In either case the measurement should have been a minimum of 3.5m.

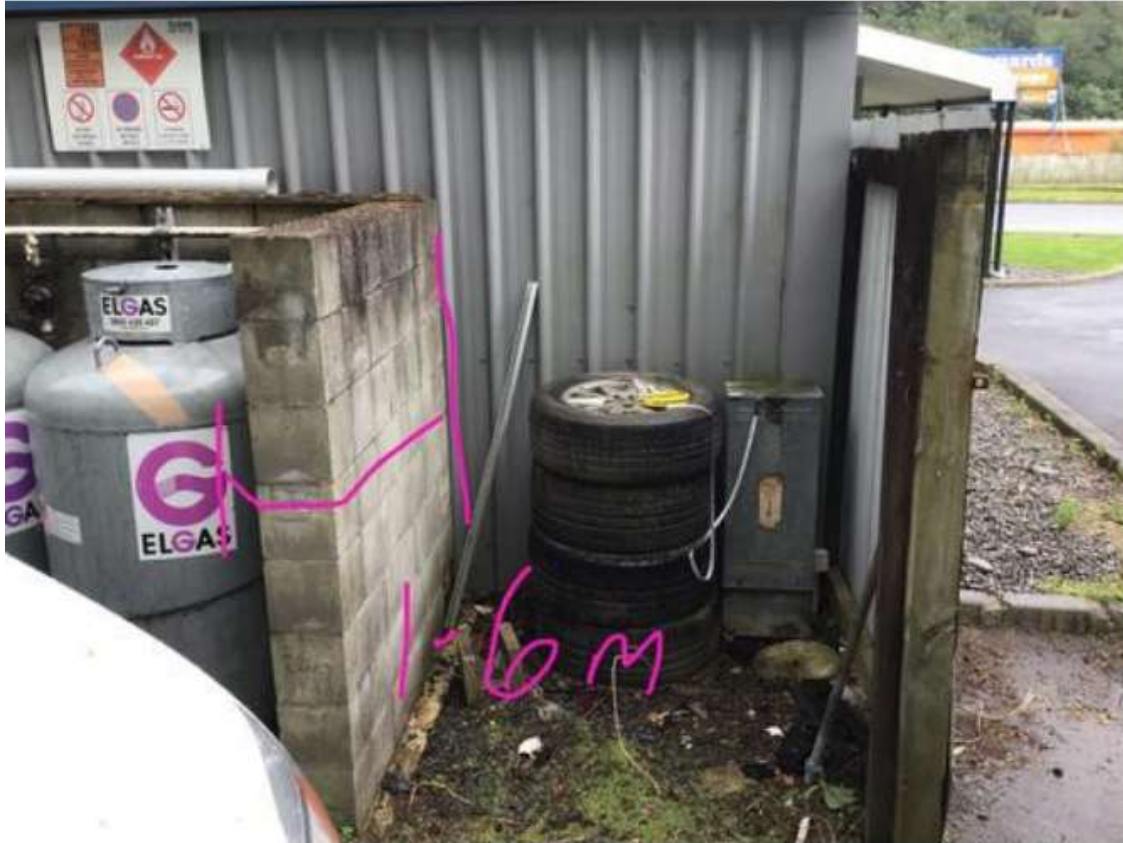
Issue #2 _11.20(5)(b)(i)(B) Separation from a Protected Place: requirements not met

A wing wall was constructed around the LPG cylinders. However, this enclosure did not meet the requirements. The distance from the cylinder on the right-hand end to the protected place is 1.6m.

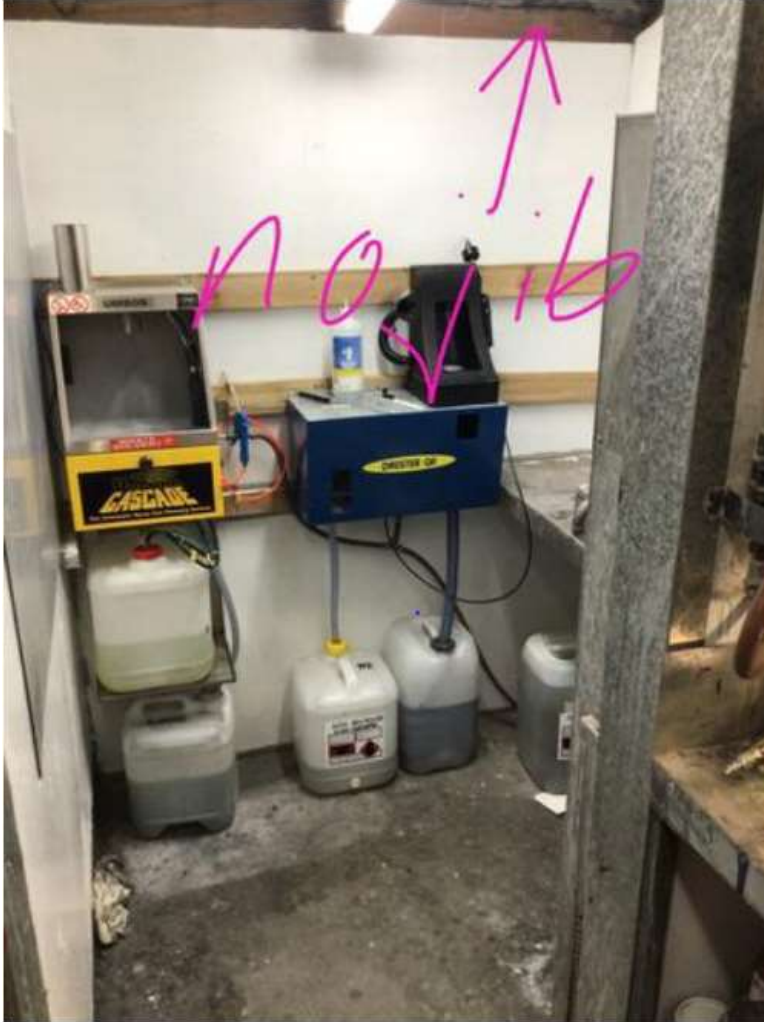
Issue #3 - NZS4114 Paint Mixing Room is non-compliant

- be constructed (walls and ceiling of non-combustible materials)
- have safety glass and no evidence could be produced to confirm it was.

There is no proof that safety glass was used. Photo 76 shows that the ceiling is not lined with non-combustible gib.

These items must have been the case last year and therefore this location should also have been failed.
