OUR NEW APPROACH TO SUPPLYING EVIDENCE TO WORKSAFE TO OVERCOME WORKSAFE'S RUDE AND OFFICIOUS PEOPLE

Complaint DGC file reference #37798

This location was certified in 2021 for 666kg of in-situ fill LPG and 450 litres of class 3 substances in a NZS4114 work room. There are significant problems with the prior year's certification, including those which pose serious safety issues.

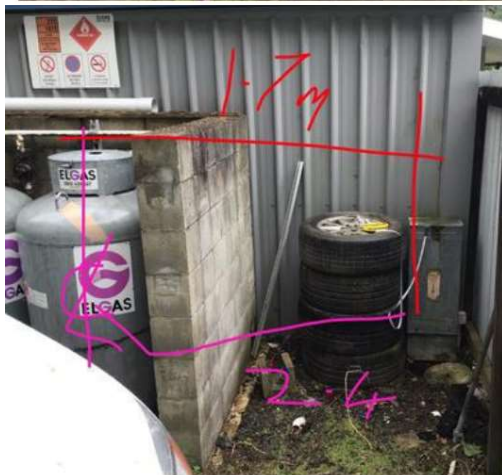
**Photo 53**

There are high voltage electrical cables/mains fuses inside the hazardous area. The site plan used last year for the certification shows that the hazardous area extended to encompass this source of ignition. The mains fuse enclosure was at ground level. The distance from the centre of the cylinders to the fuse box measured 2.4m around a wing wall, however the wing wall was not of sufficient height to mitigate the direct line measurement. In a direct line the fuse box was 1.45m. In either case the measurement should have been a minimum of 3.5m.
